INFLUENCE OF MICROSTRUCTURE AND MICRODAMAGE PROCESSES ON FRACTURE AT HIGH LOADING RATES

Final Report

By: J. H. Giovanola, R. W. Klopp, J. W. Simons,
T. Kobayashi, and D. A. Shockey

SRI International
333 Ravenswood Avenue
Menlo Park, California 94025-3493
(415) 326-6200
TWX: 910-373-2046
Telex: 334486

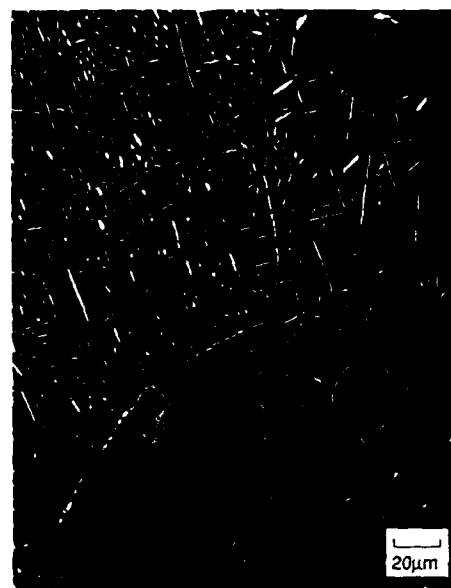
RP-1750-121

Figure 2. Three investigated microstructures.
 (a) and (b) 820° C ST, 0% α_p ; (c) 790° C ST, 12% α_p (d) 760° C ST, 40% α_p .

The heat treatment for each microstructure is listed in Table 2. The corresponding microstructures are illustrated in Figure 2. The 820°C, or β -solution, treatment resulted in a microstructure without α_p (0% α_p). The 790°C and 760°C solution treatments resulted in microstructures with approximately 12% and 40% α_p content, respectively. We determined the α_p content by the point count grid method on small trial coupons used in a preliminary investigation to evaluate the solution treatment response of the as-received material. Subsequent metallography on heat-treated fracture specimens revealed some variability in the α_p from specimen to specimen for a given solution treatment. We also observed some inhomogeneity in the α_p content within a given specimen. Therefore, some fracture specimens solution-treated at 790°C may actually have a somewhat higher α_p content, and some fracture specimens solution-treated at 760°C may have a somewhat lower α_p content. Thus, the values of 40% and 12% α_p content are nominal values.

The 0% α_p microstructure had recrystallized equiaxed grains of 50-300 μm . A continuous α layer precipitated at the grain boundaries during aging. The α_p -containing microstructures had a more elongated grain structure resulting from the thermomechanical

treatment. The grain aspect ratio was roughly 1:2 to 1:4, and the grain size also varied between approximately 50 and 300 μm . We observed a variety of morphologies for the α_p phase, ranging from fine globular particles to elongated platelets. Some regions contained large globular α_p particles, while others had an agglomeration of thick platelets adjacent to a depleted region. The α_p -containing microstructures also had continuous and discontinuous grain boundary and sub-grain boundary α_p films. The tensile properties for the three microstructures are listed in Table 3. These properties were measured in duplicate with tensile bars heat-treated at the same time as the fracture specimens. The 0% and 40% α_p microstructures had almost identical stress-strain curves, whereas the 12% α_p microstructure had a strength 12% higher than that of the other two microstructures.
